# Manhole Inspection Summary

Manhole # S21E1\_001MH

Insp Date: **5/22/08 1:09 PM**

**Location** Address: **2651 banger-harman alley**

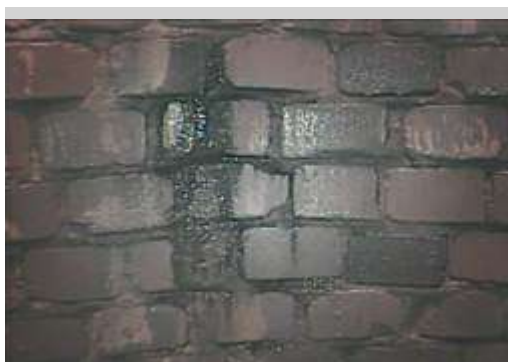
Defect 5

Infiltration: ☐ None ☐ Joint ☐ Cracks ☐ Mortar ☐ Roots ☒ **Wall**

infiltration @ barrel wall

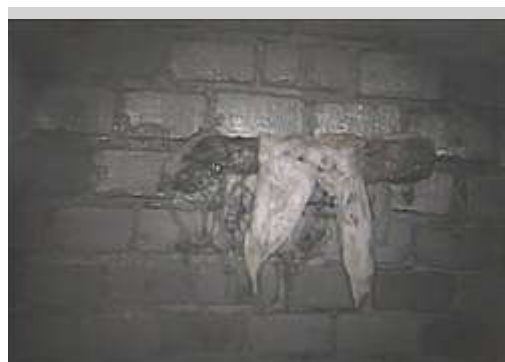
Defect 4

☒ **Evidence Of Surcharge** Depth: **5** (ft.) ☐ Active Surcharge Present

surcharge evidence

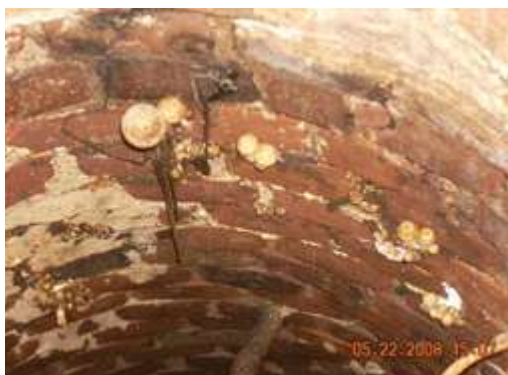
Defect 3

Condition: ☐ Sound ☐ Cracked ☒ **Root Intrusion** ☐ Loose Brick ☐ Deteriorated

root intrusion/fungi @ corbel wall

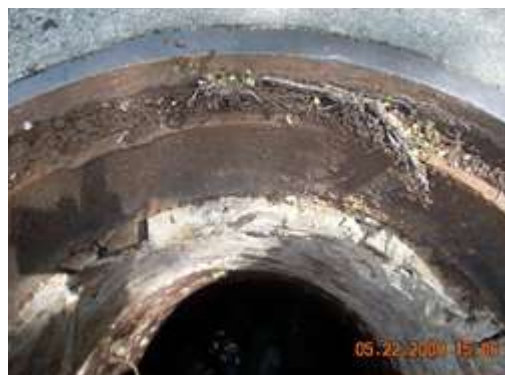
Defect 2

Offset: **1** (in.)

frame offset

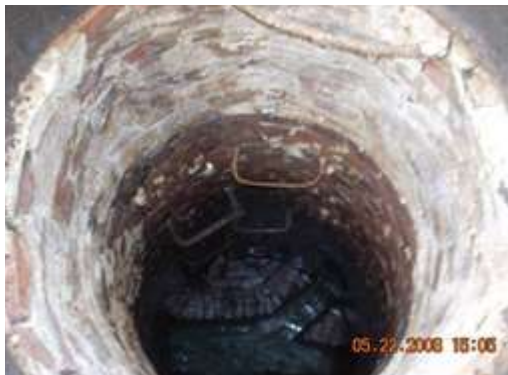
### Defect 1

Count: **6** Missing: **2** ☒ **Corroded**

corroded and missing steps

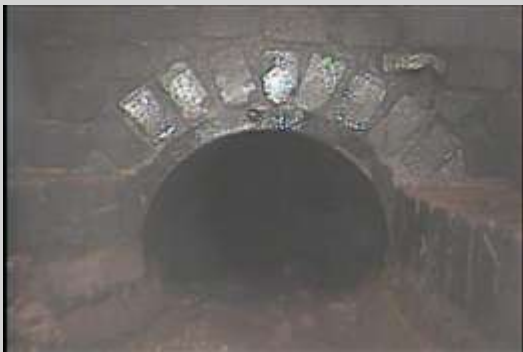
12 O'Clock Outflow

Pipe Height: **15.6** (in.) Rod and Bar (Angled)  
Pipe Material: **Clay** ☐ Pipe Lined  
Invert Depth: **13.00** (ft.) Flow Characteristics: **Fast**  
Deposits: ☒ None ☐ Mud ☐ Sludge ☐ Debris ☐ Grease  
Silt Depth: **0** (in.) Deposits Extent:  
Infiltration: **None** Pipe Seal Cond: **Sound**

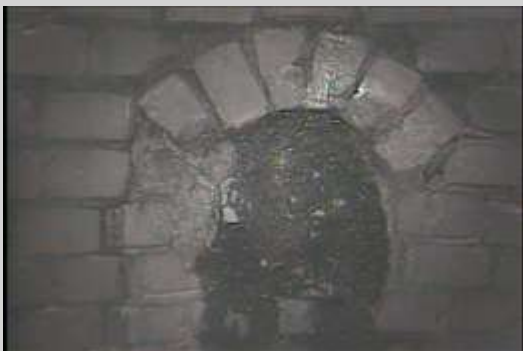
5 O'Clock Inflow

Abandoned (Sealed)

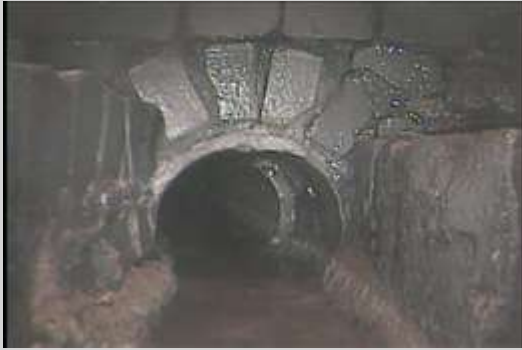
5 O'Clock Inflow

Pipe Height: **8.4** (in.) Rod and Bar (Angled)

Infiltration: **None** Pipe Seal Cond: **Sound**

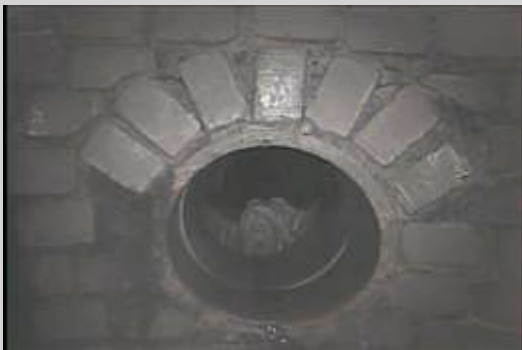
6 O'Clock Inflow

Pipe Height: **10.8** (in.) Rod and Bar (Angled)

Infiltration: **None** Pipe Seal Cond: **Sound**

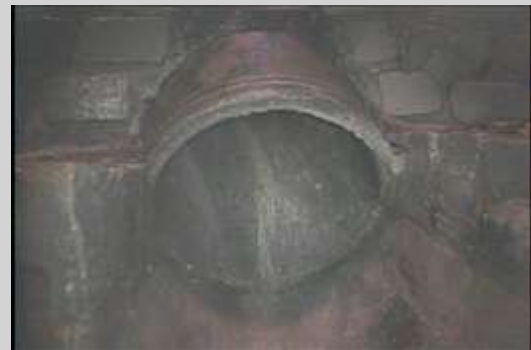
Drop In @ 6 O'Clock

Drop: **Outside** Rod and Bar

Drop Condition: **Open**

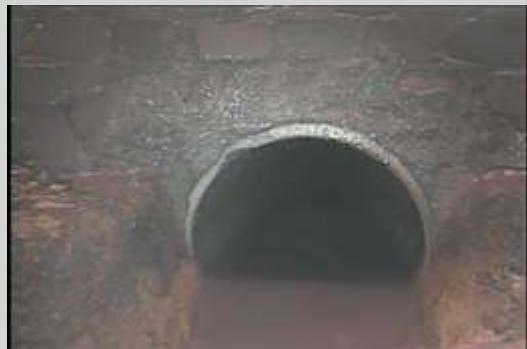
9 O'Clock Inflow

Pipe Height: **12** (in.) Rod and Bar (Angled)

Infiltration: **None** Pipe Seal Cond: **Sound**
